**Prepared For:** Mike Sample

**Property Address:** 7777 Your Street  
Any Where, FL 7777

**Inspector:** Michael Strohmenger  
**Company:** Mike's Home Inspection of Delray Beach, LLC  
dba WIN Home Inspection Delray Beach  
(561) 638-9228  
mstrohmenger@wini.com

Extended Home Inspection

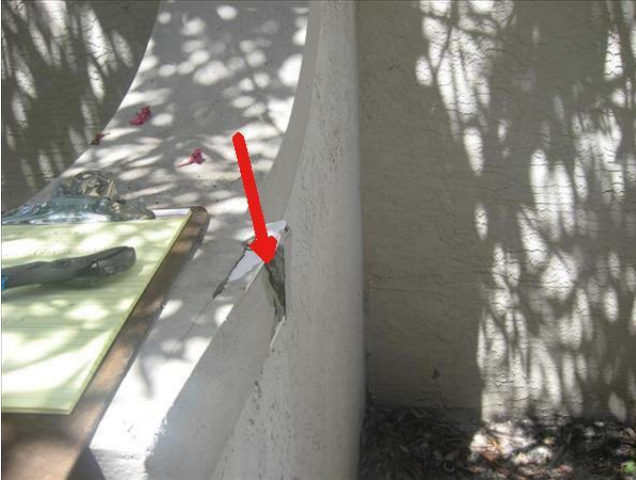
Figure 1

Exterior Structure  
Siding Condition  
Maintenance  
Siding on decorative wall in need for repair

- right elevation cracks in decorative wall; siding in need for repair

*The inspector recommends: contacting a qualified handy person for repair. Home Tech cost estimate for repair is approximately \$150 - \$200.*

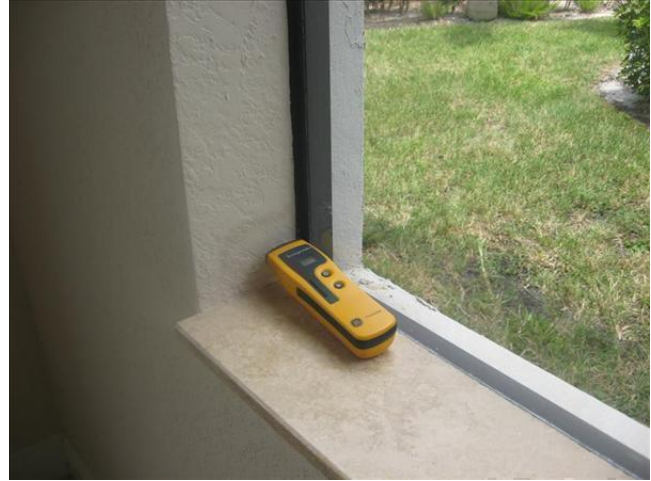
Figure 2

Exterior Structure  
Caulking Structure  
Maintenance  
Evidence of water intrusion; NO active moisture meter reading

- The caulking around the windows and exterior doors is showing wear
- Multiple exterior windows / doors evidence of water intrusion; 30% moisture meter reading*  
*The visible damage may not be the total damage present.*

*The inspector recommends: contacting a qualified handy person for repair.  
Home Tech cost estimate for repair is approximately \$300 - \$400.*

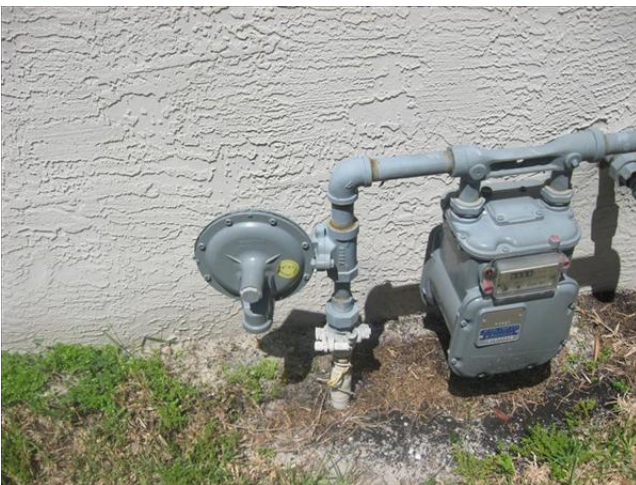
Figure 3

Utility Services  
Gas Service  
Natural  
Shut off at time of inspection

*The inspector recommends purchasing an emergency shut off tool for the gas meter. A crescent wrench or special shut off tool can be purchased at your local hardware or home improvement center. The inspector recommends attaching it with a piece of string to the meter for easy accessibility in an emergency.*

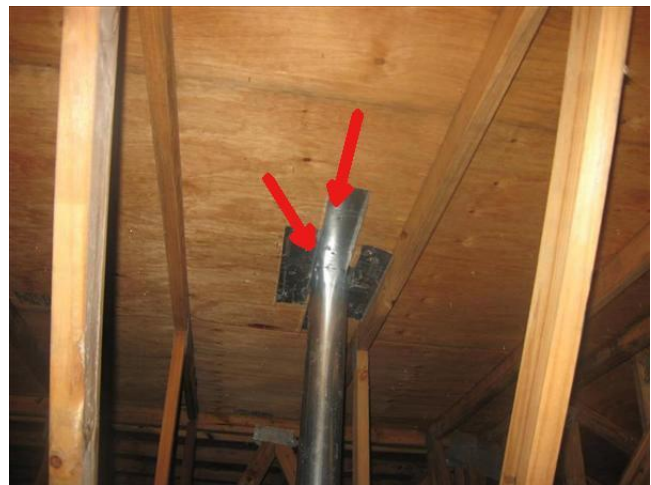
Figure 4

Roof  
Flashing/Caulking  
Maintenance  
Dryer vent visible light

*The inspector recommends : contacting a licensed and experienced roofing contractor for repair of the roof vent termination.*

*Home Tech estimate for repair is approximately \$300 - \$xxx.*

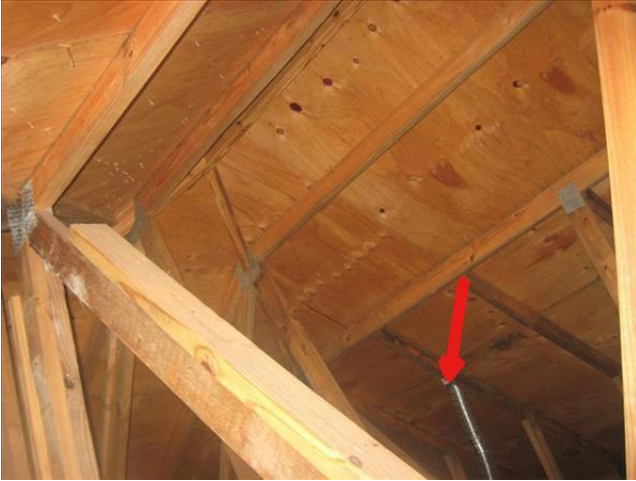
Figure 5

Roof  
Flashing/Caulking  
Maintenance  
Bathroom vents visible light

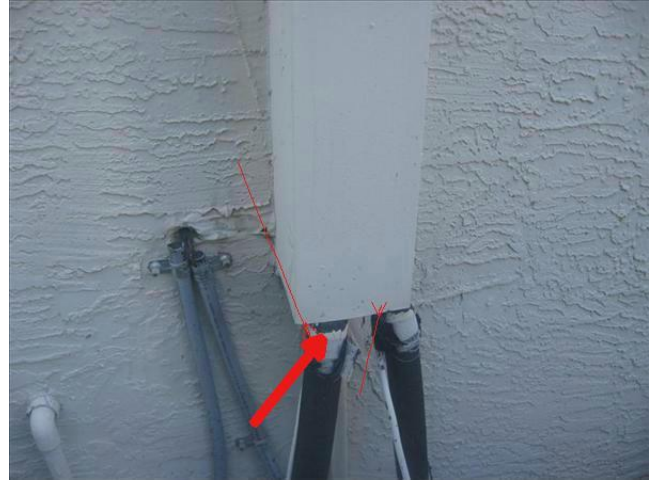
Figure 6

Air Conditioning  
Systems Operation  
Maintenance  
All access ways open; risk of animal entrance to structure

*The inspector recommends: contacting licensed and experienced HVAC contractor for repair prior to closing.*

*Home Tech cost estimate for repair is approximately \$200 - \$250.*

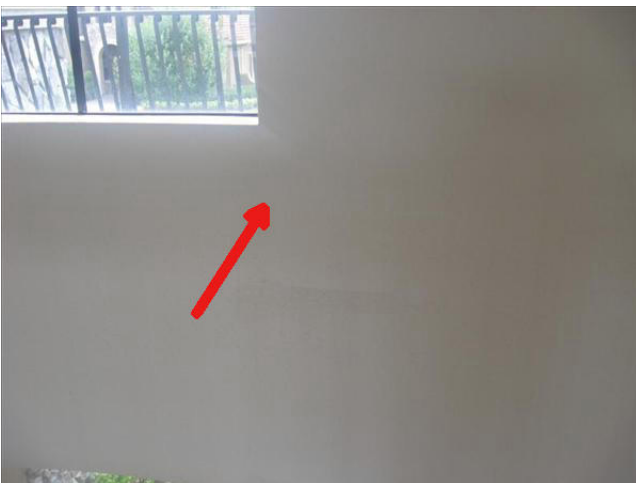
Figure 7

- at the front elevation one or more windows show evidence of water intrusion
- there are moisture stains on wall above main door; NO active moisture meter reading

The visible damage may not be the total damage present.

This condition is conducive to mold growth that could be present in areas not readily visible. Thought should be given to indoor air sampling, which may identify the type(s) of mold present, if any, and the concentrations of mold spores. For additional information or mold testing please contact this inspection company.

Living Room / Main Hall  
Ceiling/Walls/Doors  
Attention  
Moisture stains above main door

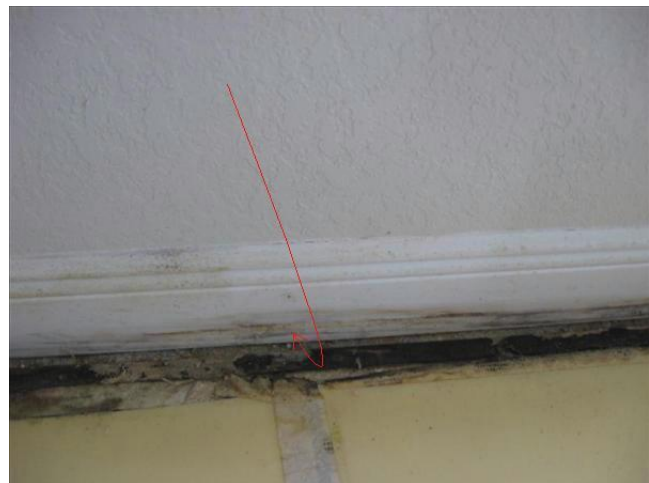
Figure 8

- At the back elevation first floor bedroom around window and floor showed evidence of water intrusion; no active moisture meter reading suspected mold in one or more areas

The visible damage may not be the total damage present - Hidden damage maybe present

This condition is conducive to mold growth that could be present in areas not readily visible. Thought should be given to indoor air sampling, which may identify the type(s) of mold present, if any, and the concentrations of mold spores. For additional information or mold testing please contact this inspection company.

Bed Room  
Ceiling/Walls/Doors  
Action Required  
First floor evidence of water intrusion; NO active moisture meter reading

The inspector recommends contacting a licensed and experienced contractor to determine corrective action and repair cost prior to closing

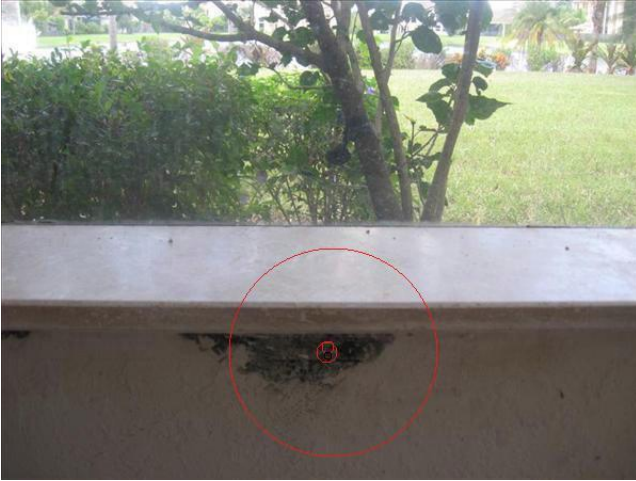
Figure 9

Bed Room  
Ceiling/Walls/Doors  
Action Required  
Evidence of water intrusion; NO active moisture  
meter reading
