Prepared For: John Doe

Property Address: 123 John Doe Street
Albuquerque, NM 87120

Extended Home Inspection

Extended Home Summary Report

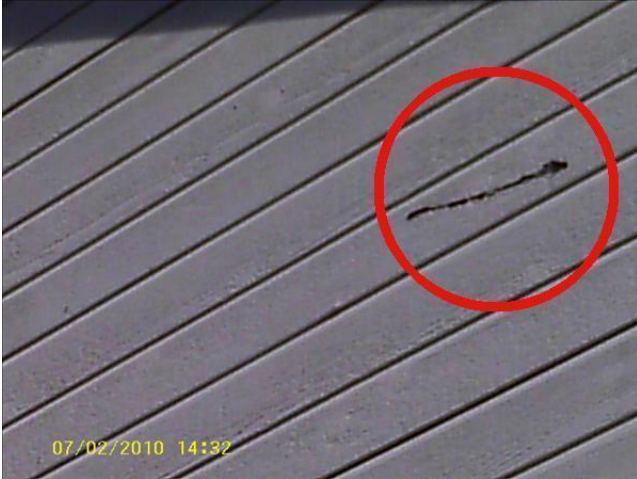
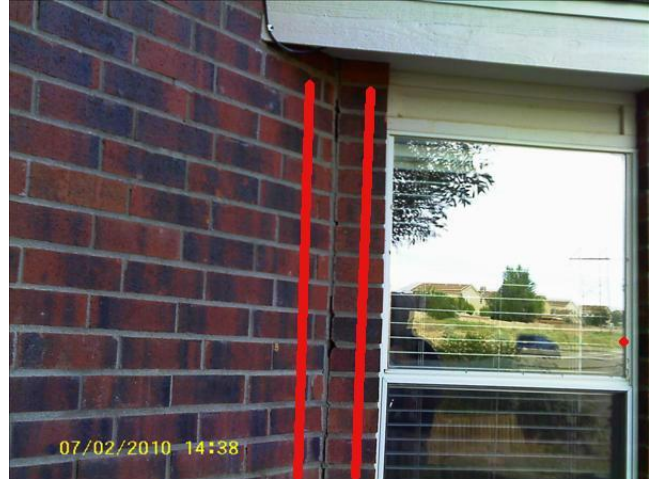
The inspection revealed a tear in the fiberboard siding on the South East side of the house. Also noted was missing mortar at the junctions of the kitchen bay window framing. Recommend service to these areas to reduce the possibility of moisture penetrating the structure.

Exterior Structure
Siding Condition
Maintenance

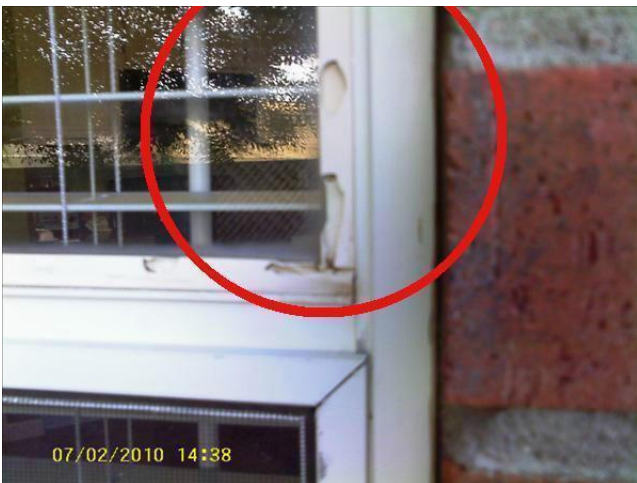
Figure 3

The exterior window vinyl glazing strips on the south west facing windows are deteriorating. These are used to hold the glass in place from the outside. We recommend repair or replacement of the damaged glazing strips so they function as designed.

Exterior Structure
Glaze/Caulking Window Pane
Maintenance

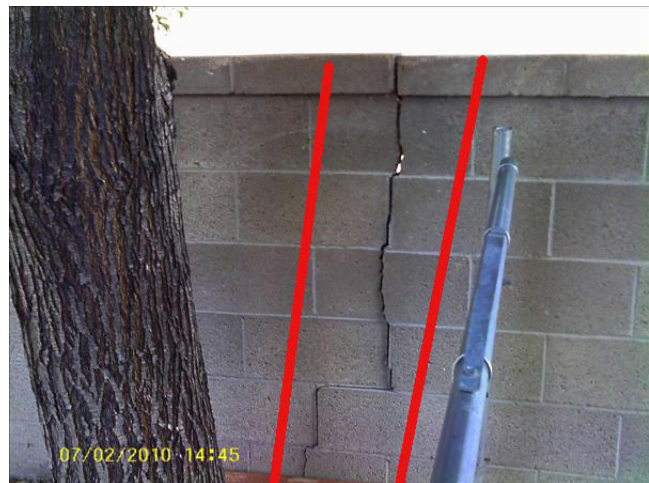
Figure 4

Heaving apparently due to tree roots has created a crack in the block wall on the west side of the house. The fence appeared to be otherwise sound, filling the crack in the wall should be considered.

Fence/Gates
Fences
Maintenance

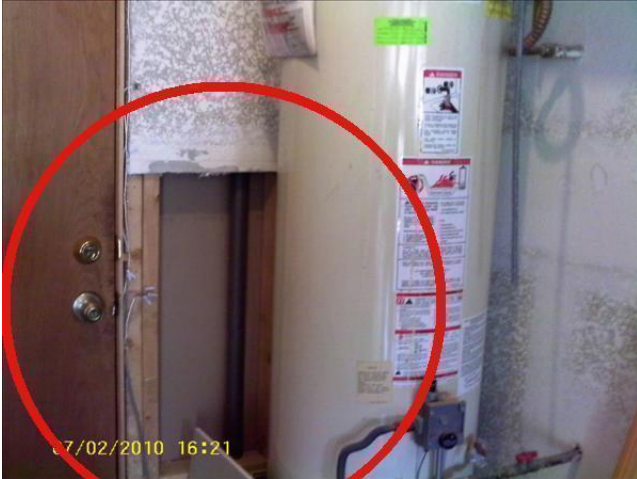
Figure 5

Attached Garage
Fire Wall/Ceiling Board
Action Required

The inspector noted that there was no firewall in place by the water heater to seal the garage from the

house and provide protection from fire in this area. It is recommended that a licensed contractor be contacted to evaluate and make needed repairs.

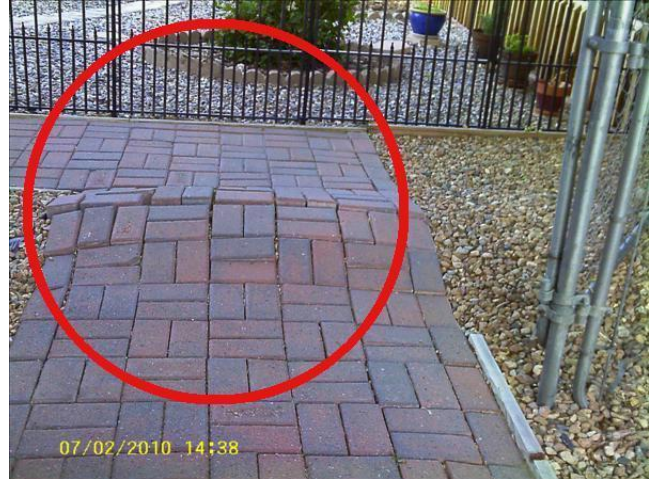
Figure 6

The brick walkway at the southwest corner of the structure has heaved creating a trip hazard. The heaving is apparently due to root from the adjacent tree. The walkway needs repair to prevent further deterioration and/or for safety reasons.

Site Concrete and Paving
Walkways
Attention

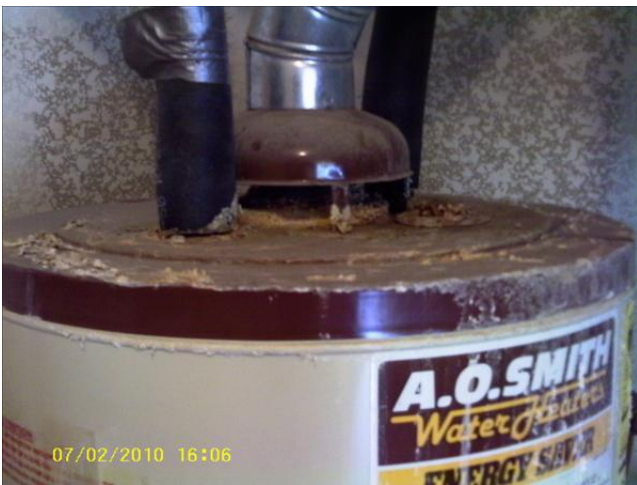
Figure 7

There are visible encrustations along the hot and cold water connections at the top of the water heater. The condition is a result of a small amount of water seeping out along the threaded connection at some time in the past. For preventive maintenance reasons, consideration may be given to removing the connections, cleaning, taping with teflon tape and reinstalling to prevent further deterioration that may result in a future leak.

Water Heater
Evidence of Encrustation
Yes

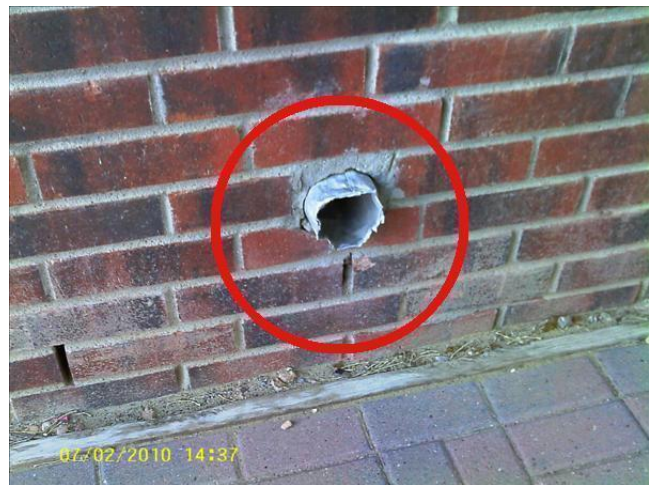
Figure 8

The dryer vent cover on the exterior of the structure is missing. Contact a qualified repair person to install cover.

Laundry Area
Dryer Ventilation System
Attention
