Prepared For: Sample Inspection Report

Property Address: XXXXXXXXXXXXX
XXXXXXXXXXXX, AB XXXXX

Inspector: John Doe
WIN Home Inspection
(206) 728-8100

Building Inspection

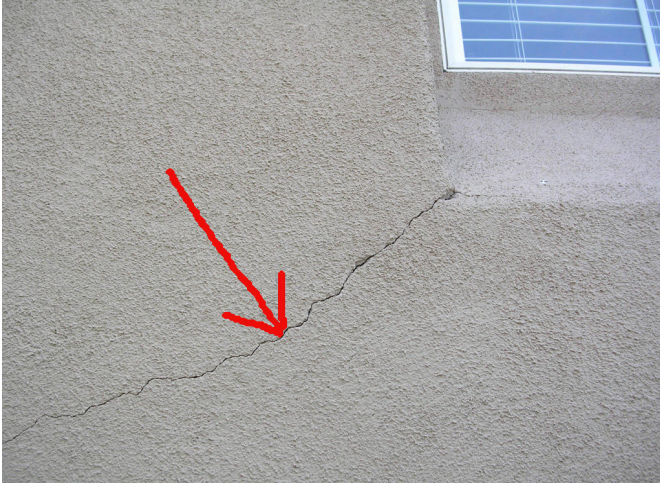
Figure 1

Exterior Structure
Flat Surface Material
Stucco
Cracking in West side wall of the home

Cracks that appear within the first 30 days after installation and are larger than 1/16" (the thickness of a penny) can be filled or repaired with the same color coat material. Cracks that are patched and re-appear could indicate a structural or substrate movement issue, necessitating the use of an elastometric coating. If a crack is visible from more than 10' away or is a source of leaking, it should be patched.

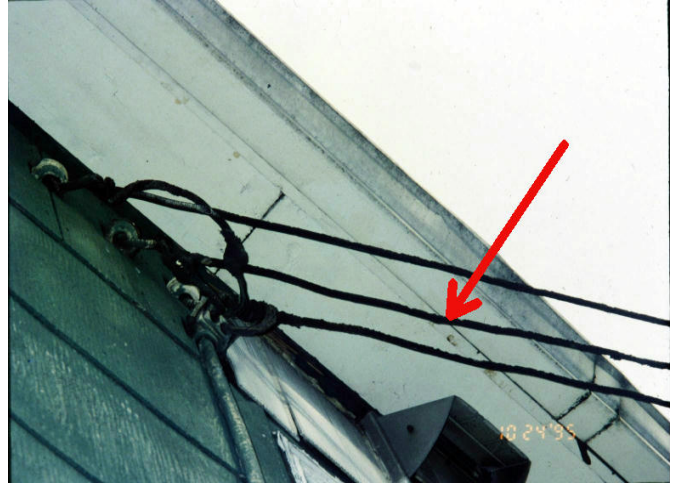
Figure 2

Utility Services
Overhead Service Lines
Action Required

The main electrical overhead service line from the street is an old three wire system. Not only is the wired frayed and beyond its useable life it comes to an outdated home attachment. We recommend contacting the utility provider to determine where there jurisdiction ends and

where the homeowners starts. Most utility companies are responsible for some if not all of the wire from the street to the meter. In this case everything to the meter and beyond may need replacement.

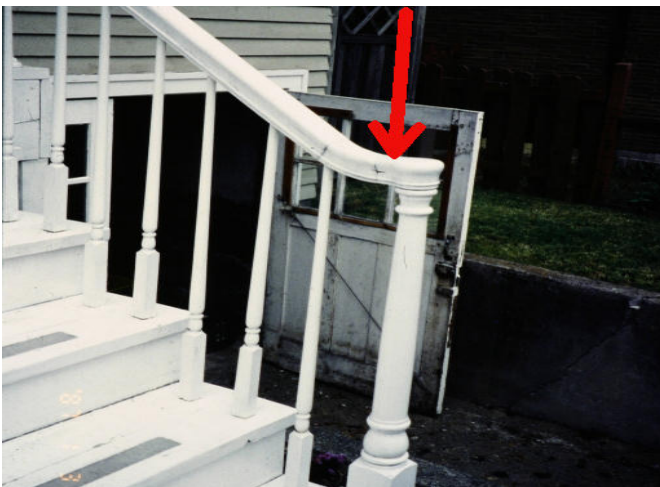
Figure 3

Patios/Decking/Porches
Steps/Handrails
Maintenance
Interior grade stair rails

The stair railing on the entry steps is made from interior grade material. Due to exposure from the elements it has begun to rot out at the bottom of the rail. The stair rail system will need to be replaced for safe functioning as designed. Contact a qualified contractor for estimates and repair.

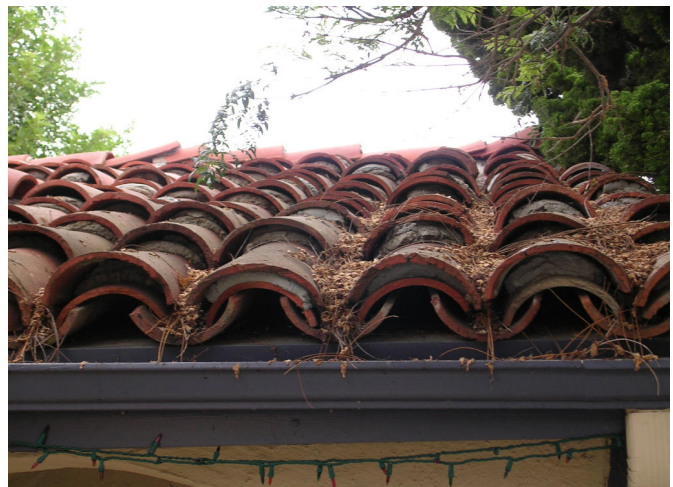
Figure 4

Roof
Debris on Roof
Maintenance
Remove debris from the tile roof

There was debris and tree branches noted on the roof cover of the home from overhanging trees at the time of the inspection. Periodic checks of the roof cover should be made for any collection of debris that should be removed as normal maintenance.

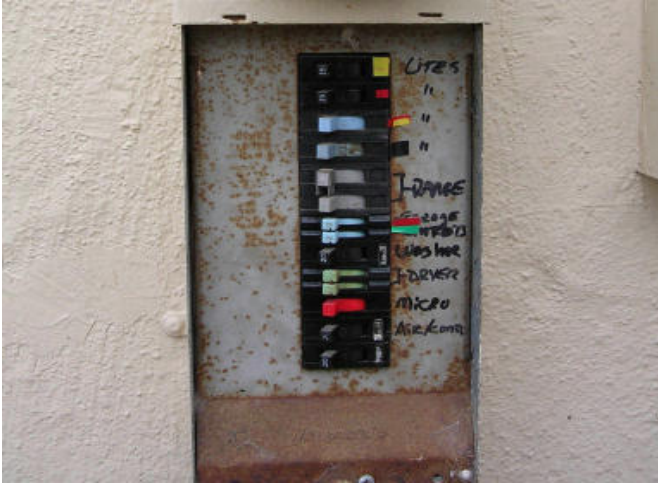
Figure 5

Electrical Service
Over Current Devices
Zinsco Breakers
Zinsco breaker panel

The electrical panel in this home is a Zinsco brand panel. Reports of failure with this brand equipment have been reported. Failure included breakers failing to trip at the stated rating, breakers that have exploded, and circuits that are still energized when the breaker is switched to the off position. Some of these panels also exhibit poor breaker connections to the bus bars. Listed replacement breakers for these panels are available but are very expensive. Many electricians advise the immediate replacement of Zinsco brand panels, though this is not the only brand of equipment that is prone to failure. Consulting a licensed electrical contractor on this matter is recommended for preventative safety considerations.

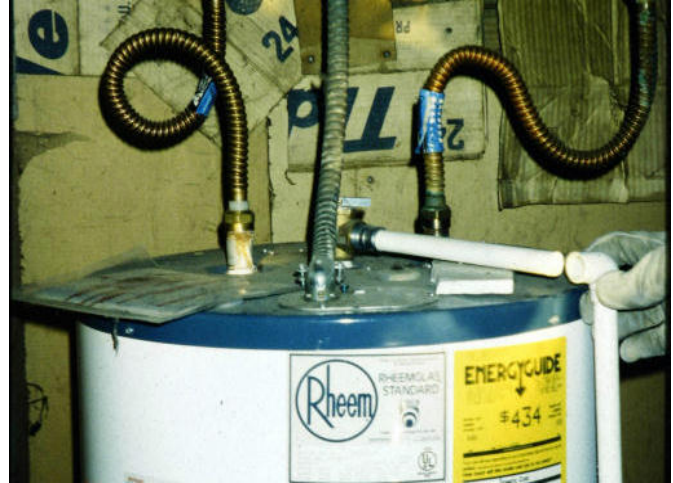
Figure 6

The discharge tube off of the hot water heater is not made of an approved material. The tube should be made of CPVC (Chlorinated polyvinylchloride) pipe, or other material which could withstand temperatures of 250' DEG F. We recommend contacting a qualified plumber / contractor to make necessary repairs. This pipe is regular PVC which is not rated for this install.

Water Heater
Overflow Pipe
Attention
PVC pipe attached to overflow. Needs proper material
